STANDARD RESIDENTIAL INSPECTION

5426 Thibault Wynd NW
Edmonton, AB T6R 3J1

MAY 13, 2022

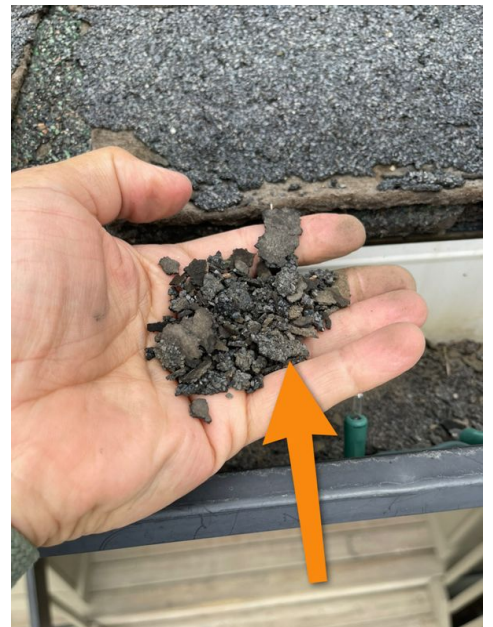
The asphalt shingle roof shows signs of delamination. Delamination is separation of the surface layer of asphalt. Recommend a qualified roofing contractor evaluate and repair to prevent further deterioration that results in leaking and moisture intrusion.

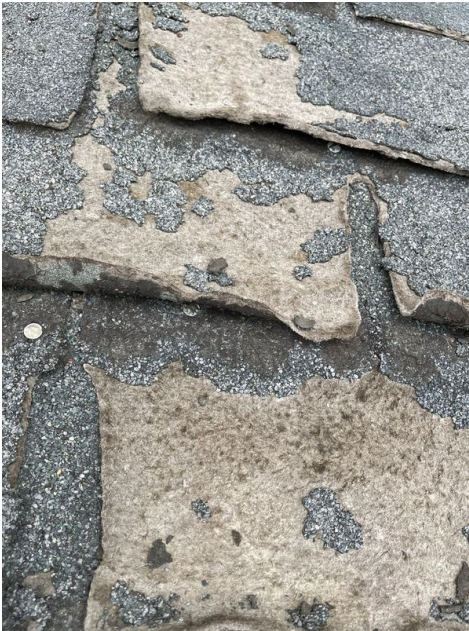
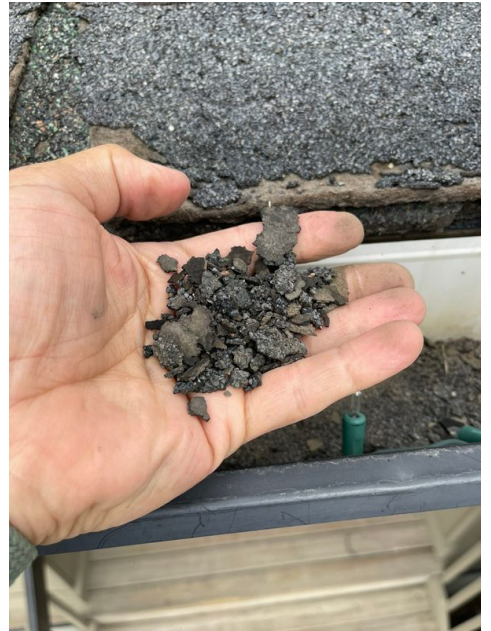
3.1.2 Roof Covering

MATERIAL DEFECT OBSERVED

Material Defect. A material defect was observed. According to the [InterNACHI Home Inspection Standards of Practice](#), a material defect is a specific issue with a system or component of a residential property that may have a significant, adverse impact on the value of the property, or that poses an unreasonable risk to people. The fact that a system or component is near, at, or beyond the end of its normal, useful life is not, in itself, a material defect.

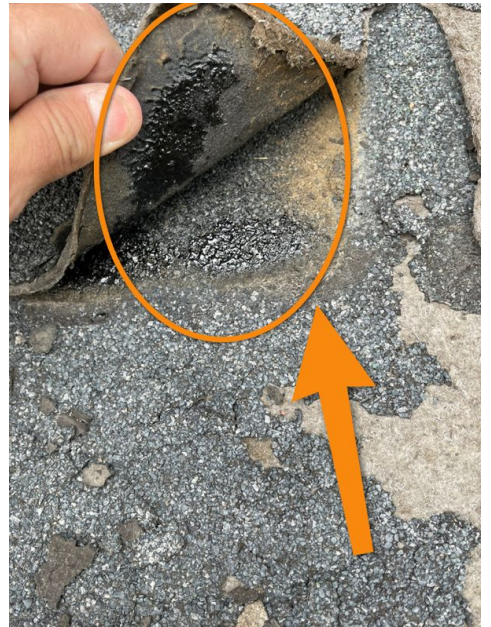
3.1.3 Roof Covering

OLD SYSTEM

I observed during my inspection that the system appeared to be old and at the end of its service life. It may not be reliable. Ask the homeowner or occupant about its recent performance. Regular maintenance and monitoring of its condition is recommended. Budgeting for repairs and future replacement is recommended. [InterNACHI's Standard Estimate Life Expectancy Chart for Homes](#)

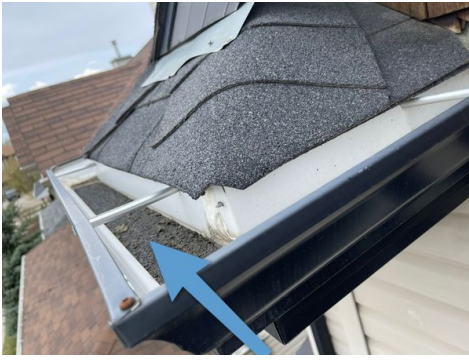
I observed debris in the gutter. Cleaning and maintenance is recommended.

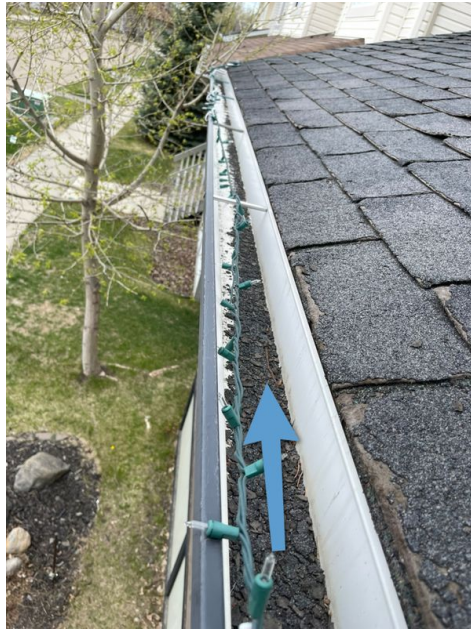
3.2.1 Gutters & Downspouts

DEBRIS IN GUTTERS

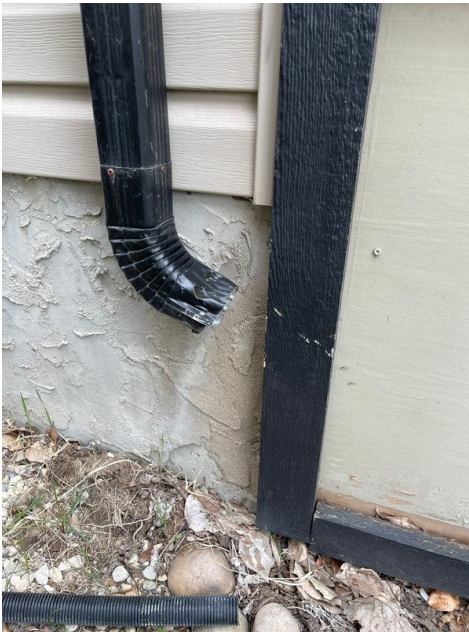
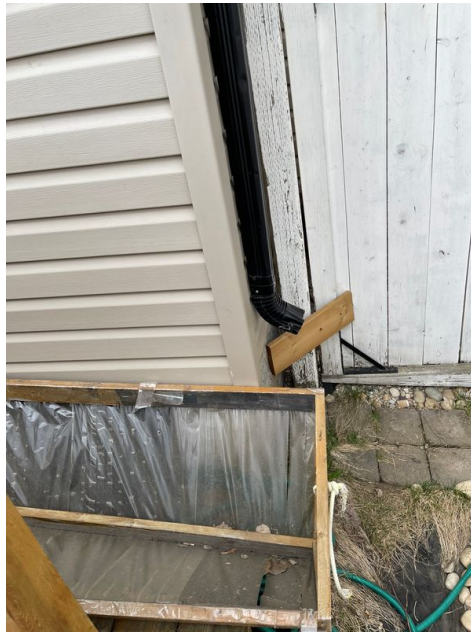
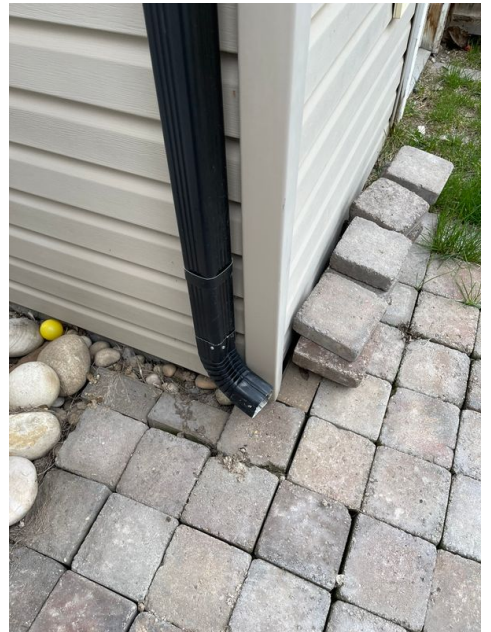
3.2.2 Gutters & Downspouts

DOWNSPOUTS DRAIN NEAR HOUSE

One or more downspouts drain too close to the home's foundation. This can result in excessive moisture in the soil at the foundation, which can lead to foundation/structural movement. Recommend a qualified contractor adjust downspout extensions to drain at least 6 feet from the foundation. A handy homeowner should be able to do this project.

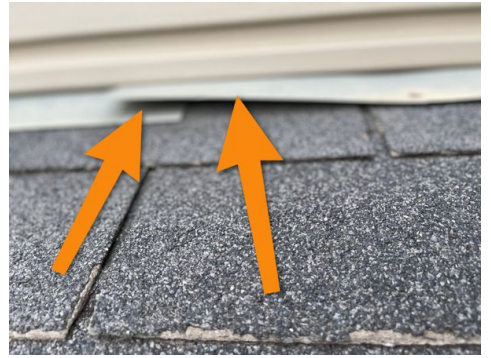
3.3.1 Flashing

LOOSE COUNTER FLASHING

I observed loose counter flashing. Counter flashing overs the step flashing areas. Loose flashing can cause roof leaks in these areas. All flashing is supposed to be water-tight or designed to divert water away from certain areas.

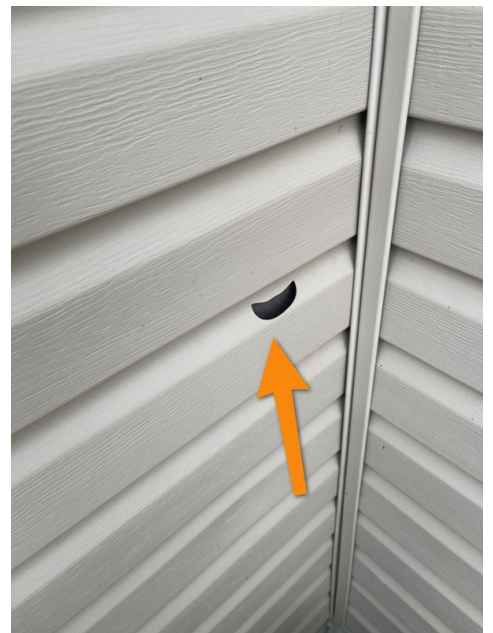
DAMAGED WALL-COVERING MATERIAL

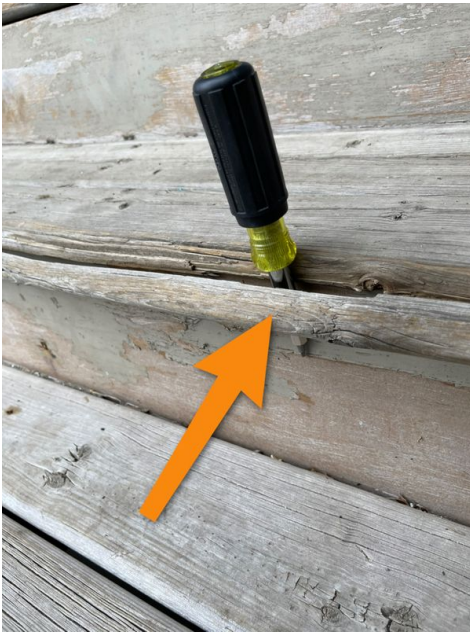
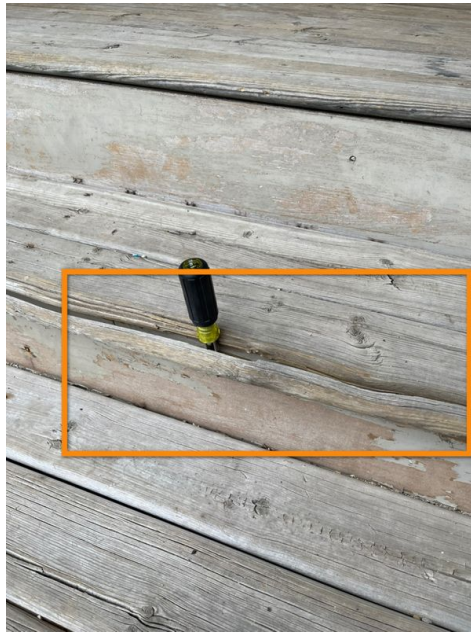
I observed a damage at a step. This condition is a safety hazard.
Correction and further evaluation is recommended.

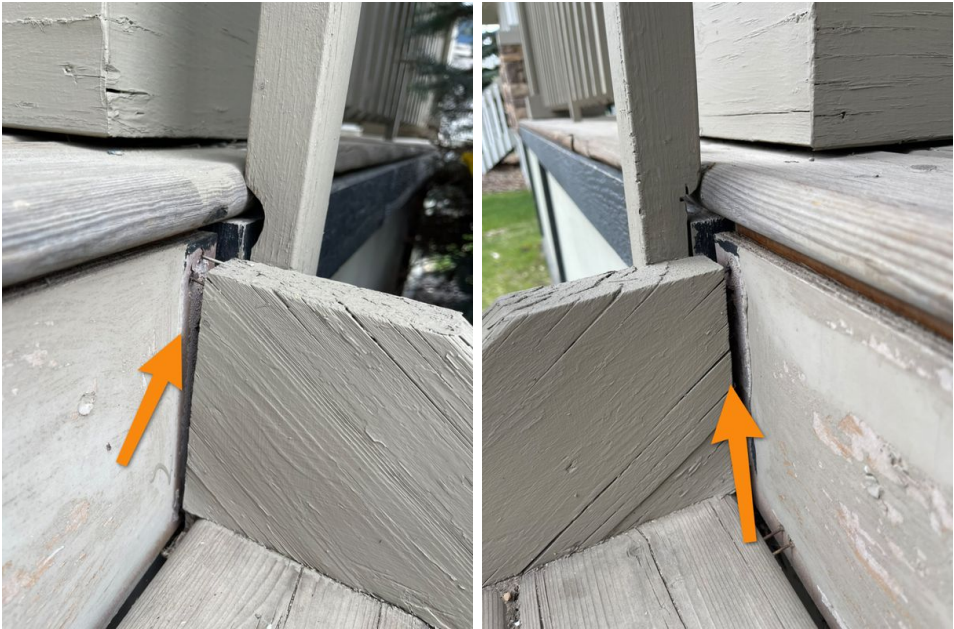
4.6.2 Stairs, Steps, Stoops, Stairways & Ramps

STAIRS PULLING/FALLING OFF LEDGER BOARD

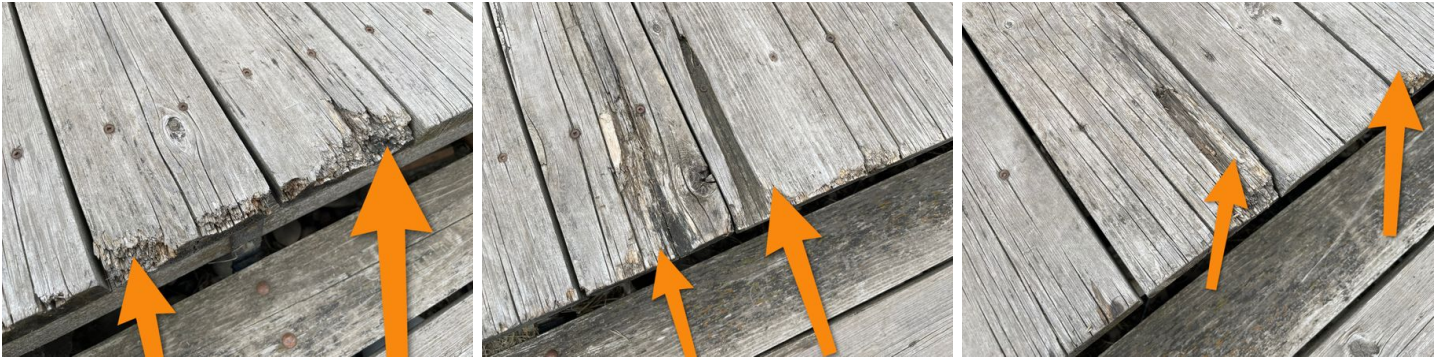
4.7.1 Porches, Patios, Decks, Balconies & Carports

DETERIORATED CONDITION AT DECK

I observed indications of deteriorated conditions at the deck components.

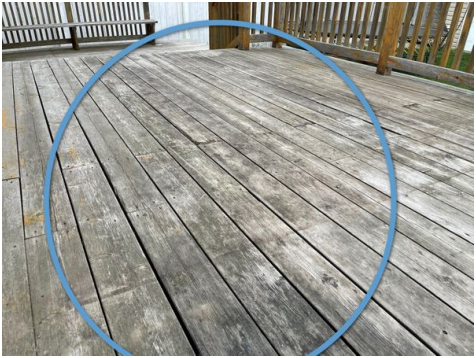
I observed indications of worn out surfaces at the deck.

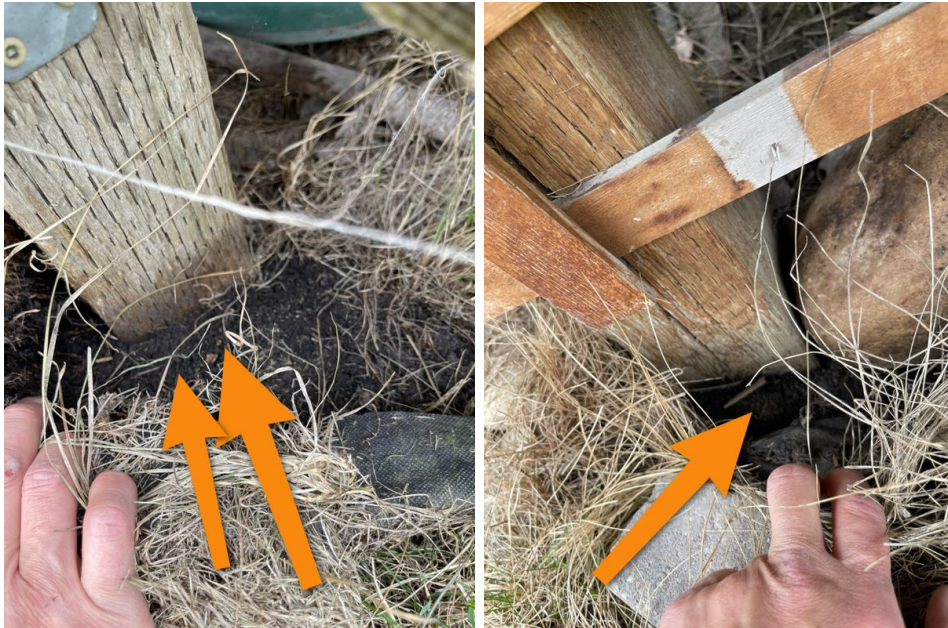
DECK - INADEQUATE STRUCTURAL COMPONENT

I observed a structural defect at the deck. Posts are sitting on the dirt, wood in contact with soil will eventually rot and sink. The deck's structural condition is inadequate. This is a major defect.

Correction and further evaluation of the deck is recommended.

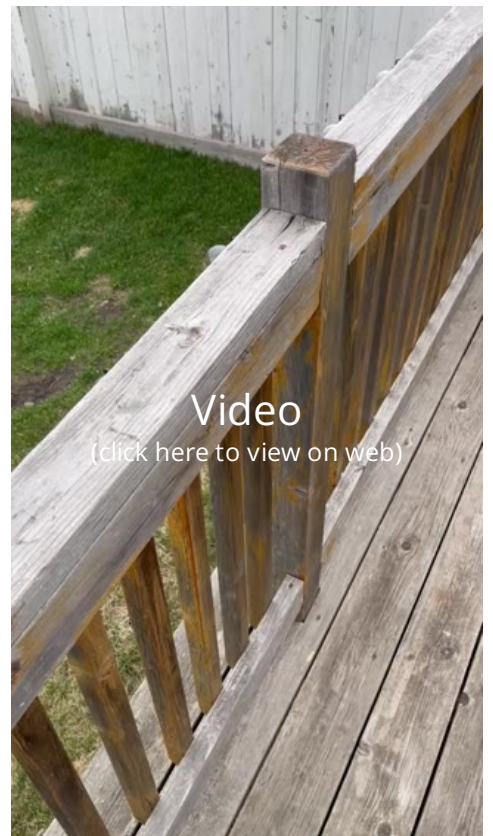
4.7.4 Porches, Patios, Decks, Balconies & Carports

LOOSE HANDRAIL

Handrail is loose and requires repair. This could cause serious injury if someone fell over or off the deck.

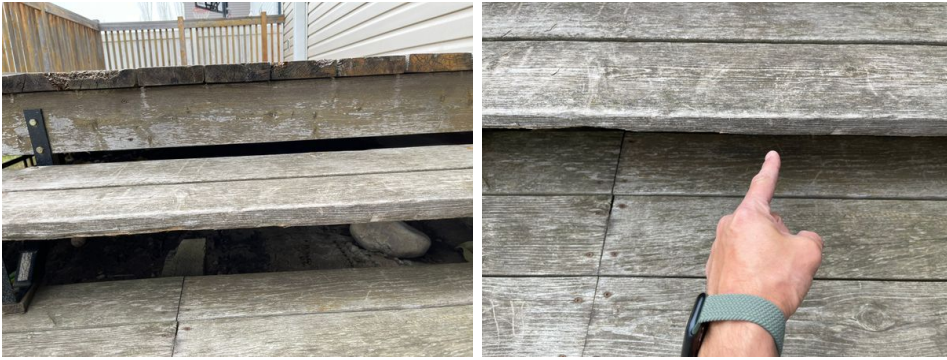
4.8.1 Railings, Guards & Handrails

STAIR COLLAPSING

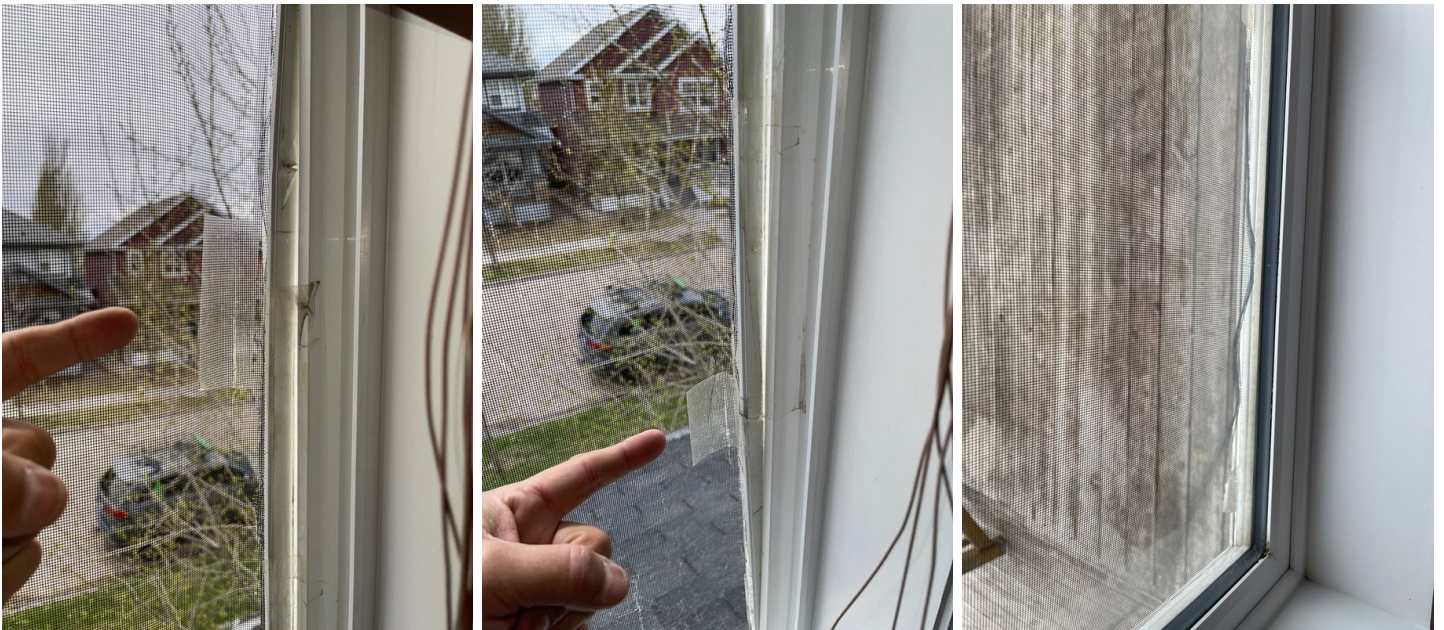
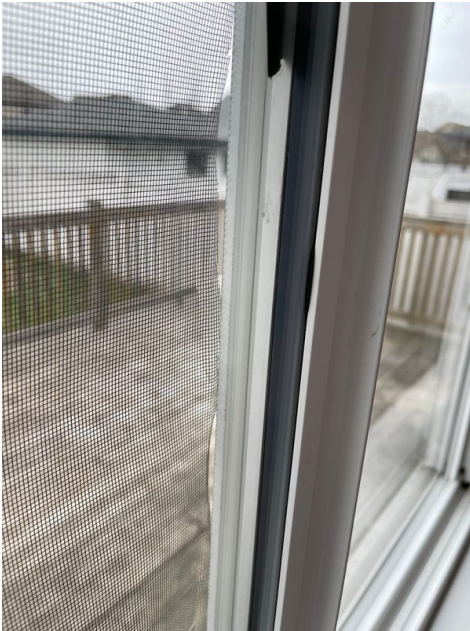
4.9.1 Windows

DAMAGED WINDOW SCREEN

I observed multiple damaged window screens

Correction and further evaluation is recommended.

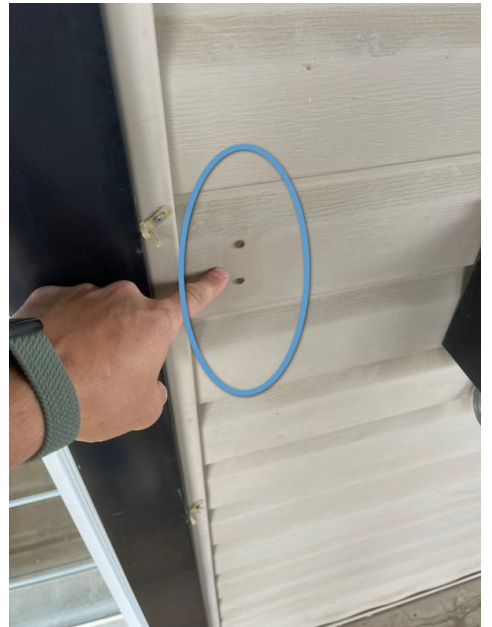
4.10.1 Exterior Doors

DOORBELL MISSING

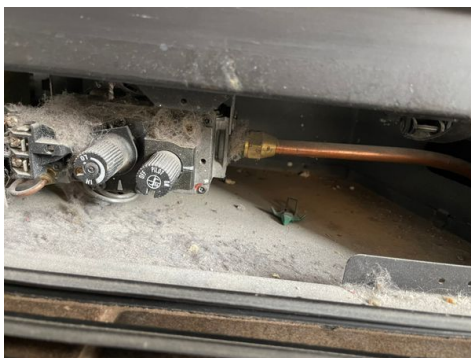
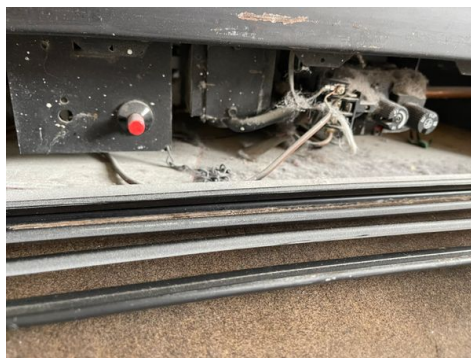
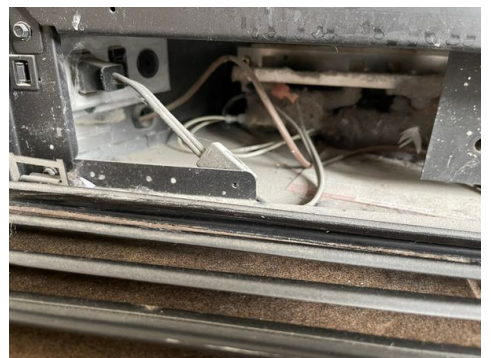
GAS INSERT - DID NOT INSPECT

I did not inspect the gas fireplace insert unit. This was beyond the scope of my home inspection. I recommend the homeowner or a professional inspect further and confirm it's safe operation and functionality.

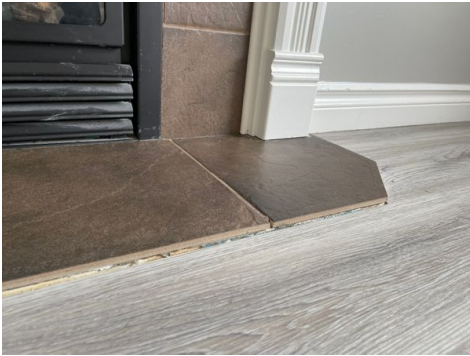
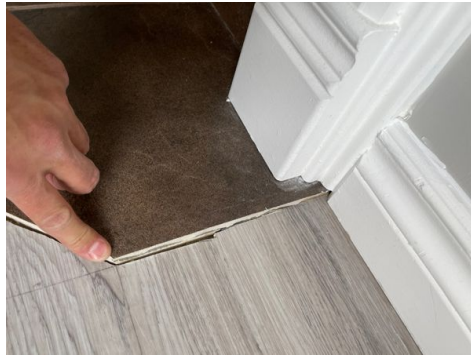
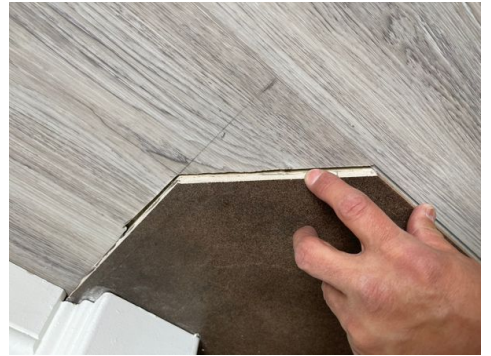
6.1.1 Fireplace

I observed indications of damage to the hearth. Hazard. Sharp edges and no finishing trim.

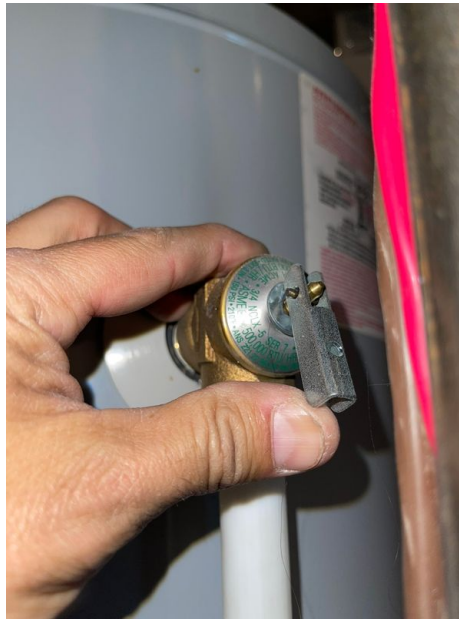
Hot Water Tank: Inspected TPR Valve

I inspected the temperature and pressure relief valve.

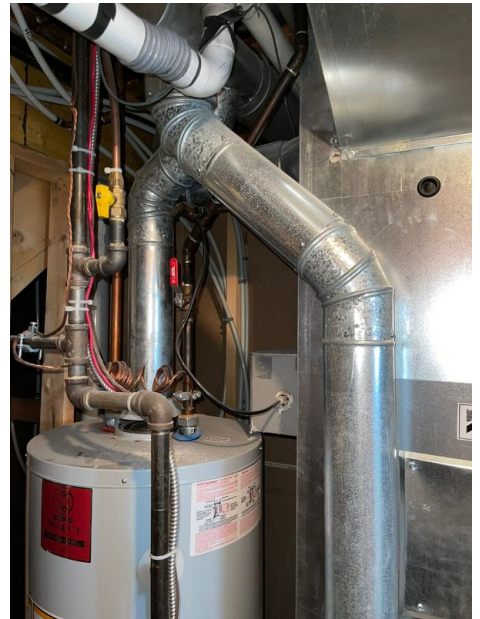
Hot Water Tank: Inspected Venting Connections

I inspected the venting connections.

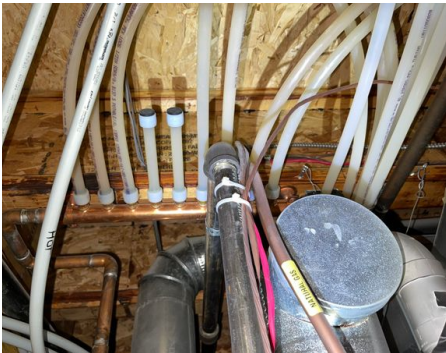
Water Supply & Distribution Systems: Inspected Water Supply & Distribution Pipes

I attempted to inspect the water supply and distribution pipes (plumbing pipes). Not all of the pipes and components were accessible and observed. Inspection restriction. Ask the homeowner about water supply, problems with water supply, and water leaks in the past.

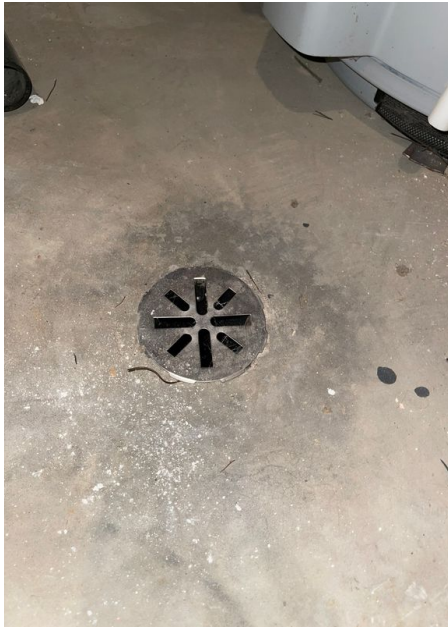
Basement Floor Drain: Inspected Basement Floor Drain

I attempted to inspect the basement drain. Not all of the pipes and components were accessible and observed. Inspection restriction. Ask the homeowner about water leaks or blockages in the past.

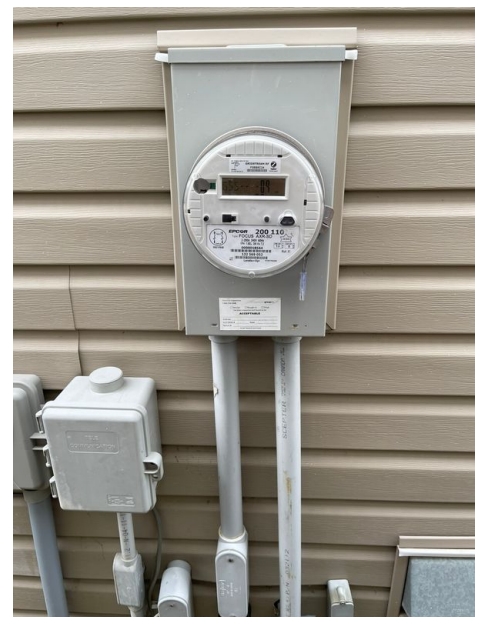
I inspected the electrical electric meter and base.

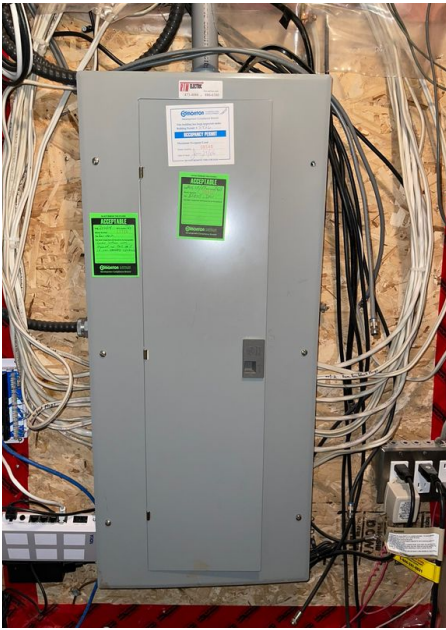
Amperage rating of system

100 amp

Main breakers only. I did not remove or inspect the main service panel for safety reasons.

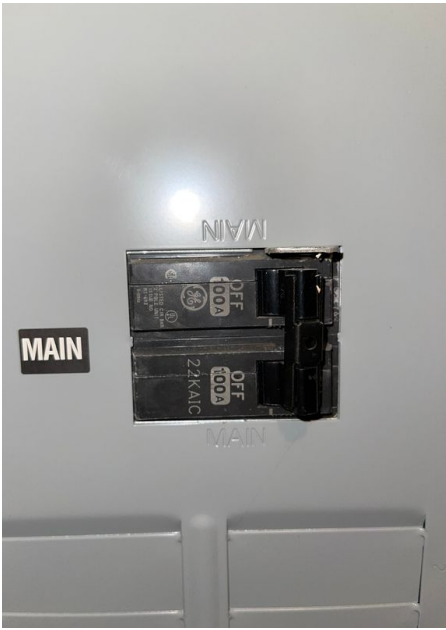
I observed indications of the main service disconnect's amperage rating. It was labeled.

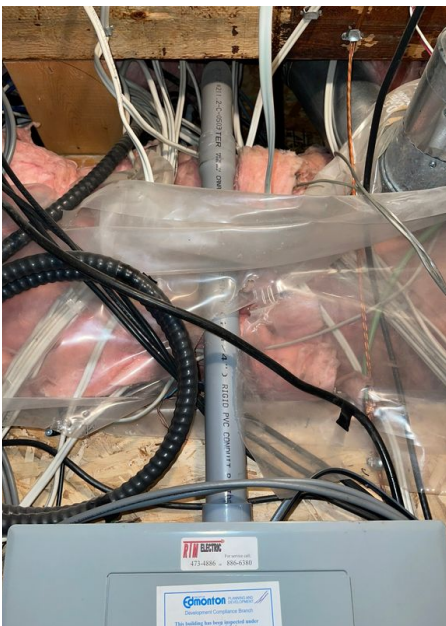
**Service-Entrance Conductors: Inspected Service-Entrance Conductors**

I inspected the electrical service-entrance conductors from the exterior. The service panel was not opened.

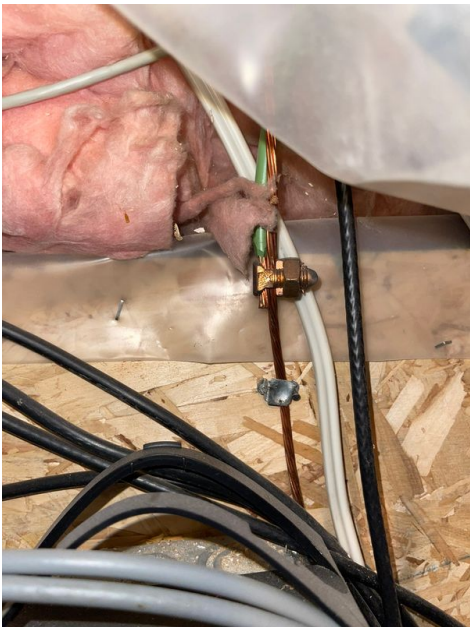
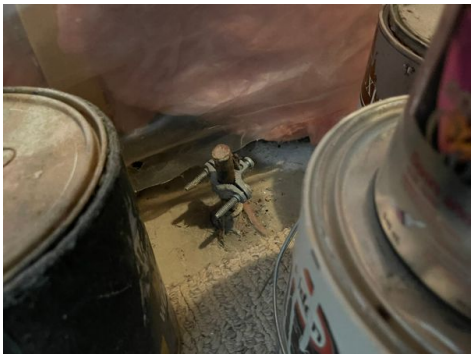
Service Grounding & Bonding: Inspected the Service Grounding & Bonding

I inspected the electrical service grounding and bonding.

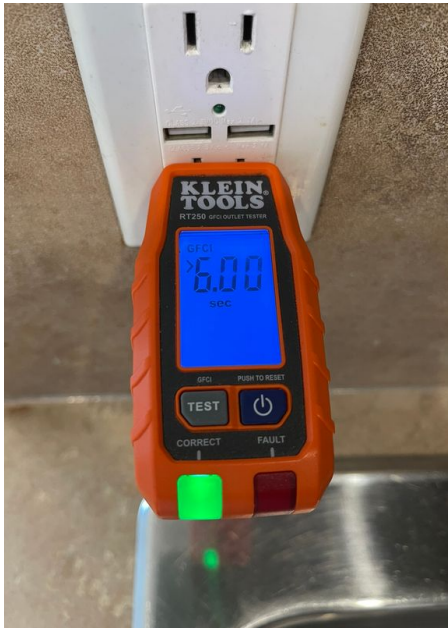
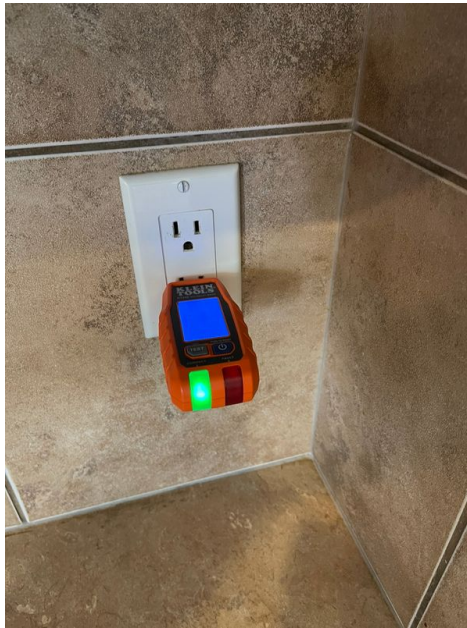
GFCIs: Inspected GFCIs

I inspected ground-fault circuit interrupter receptacles and circuit breakers observed and deemed to be GFCIs using a GFCI tester, where possible. If these are not present, that itself might not be a defect, it could mean it they were required at the time the home was built - then they would be considered a discretionary safety upgrade.

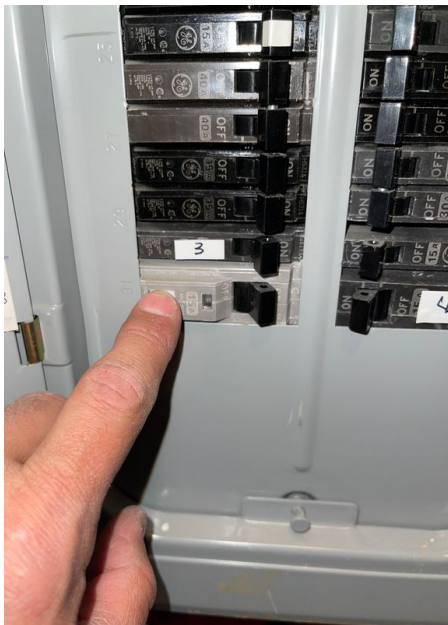
AFCIs: Inspected AFCIs

I inspected receptacles observed that were deemed to be arc-fault circuit interrupter (AFCI)-protected using the AFCI test button, where possible.

AFCI - An ARC happens when electrical currents arc or jump between 2 points. A FAULT is an unintended deviation from what was intended. The circuitry within the AFCI breaker recognizes arc-faults that can occur from damaged power cords or wires hidden behind walls and shuts off electricity before a fire can start.

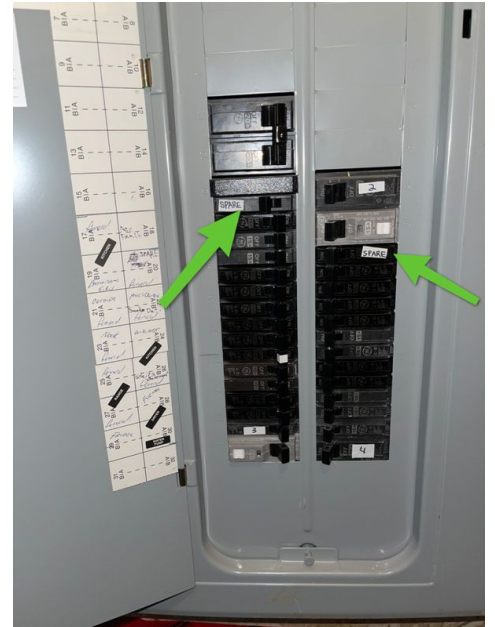
I observed a breaker in the "off" position prior to inspecting the electrical panel. Recommend asking the homeowner what this breaker is connected to, and why it is off.

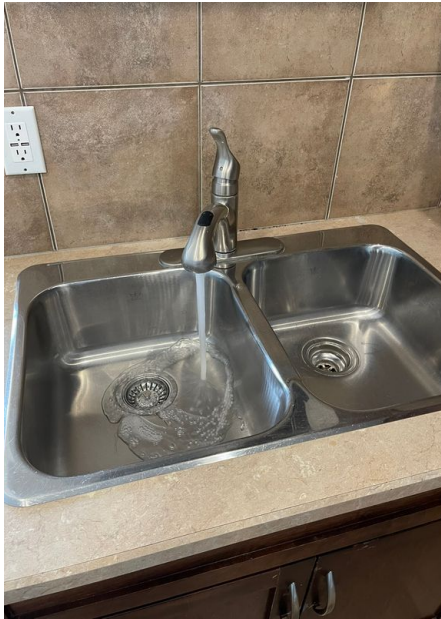
Kitchen Sink: Ran Water at Kitchen Sink

I ran water at the kitchen sink.

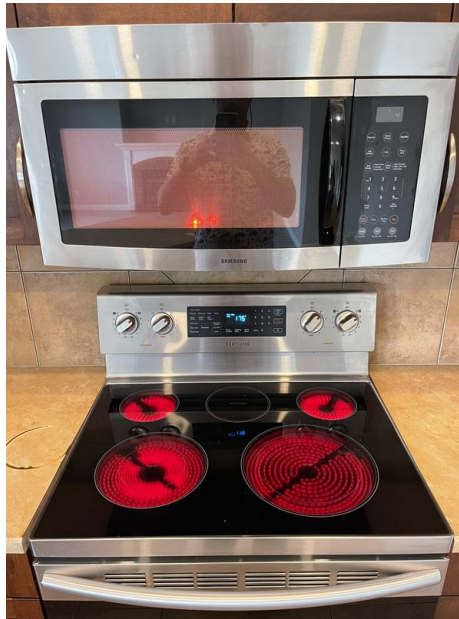
Range/Oven/Cooktop: Turned On Stove & Oven

I turned on the kitchen's stove and oven.

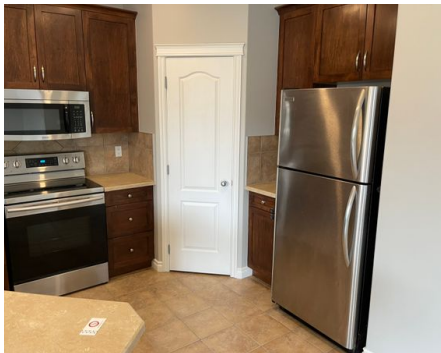
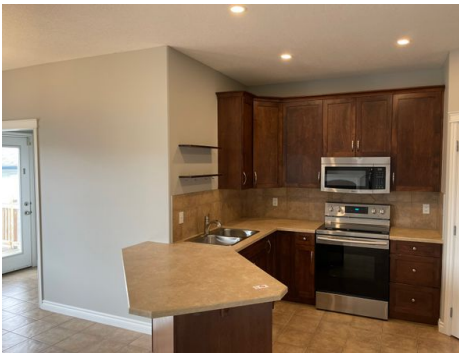
Countertops & Cabinets: Inspected Cabinets & Countertops

I inspected a representative number of cabinets and countertop surfaces.

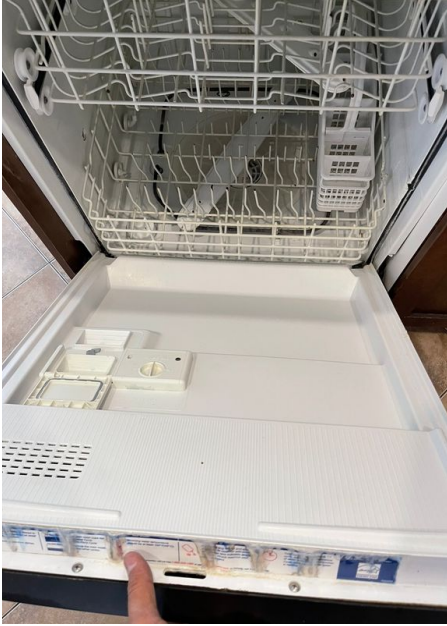
Dishwasher: Inspected Dishwasher

I inspected the dishwasher by turning it on and letting it run a short cycle.

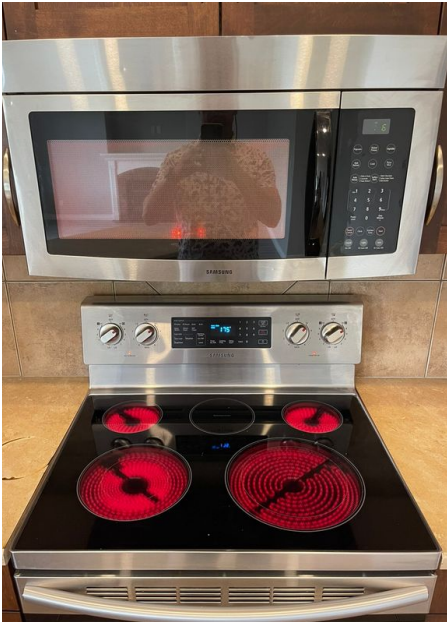
Built-in Microwave: Microwave Turned On

I observed that the microwave turned on. I used my microwave detector to verify this. Microwaves are beyond the scope of a home inspection but I do this as a client service to ensure functionality.

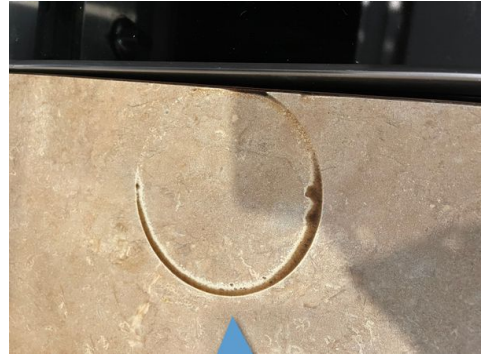
WORN AREAS AT COUNTERTOPS

Minor Defect

I observed worn areas and some damage at the countertops.

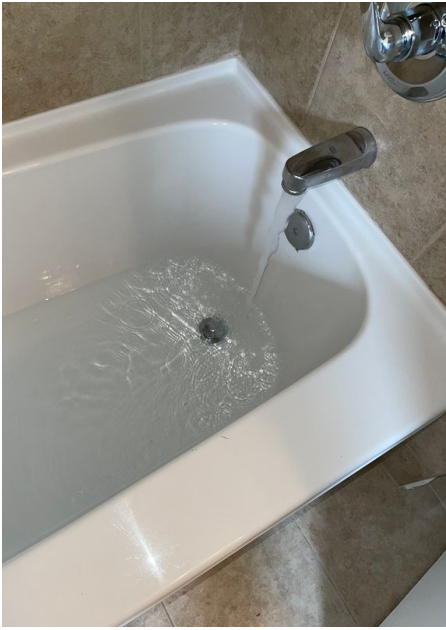
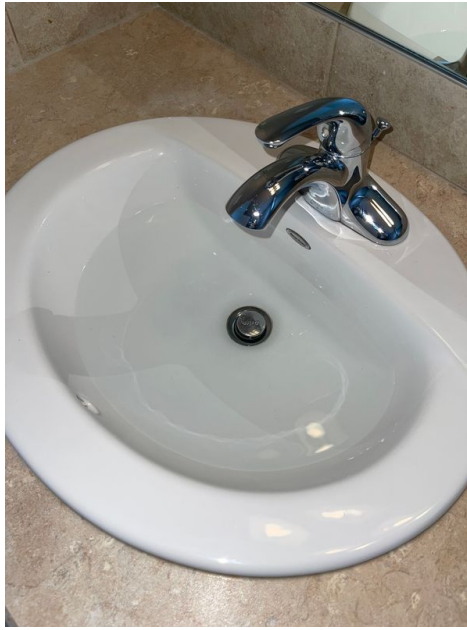
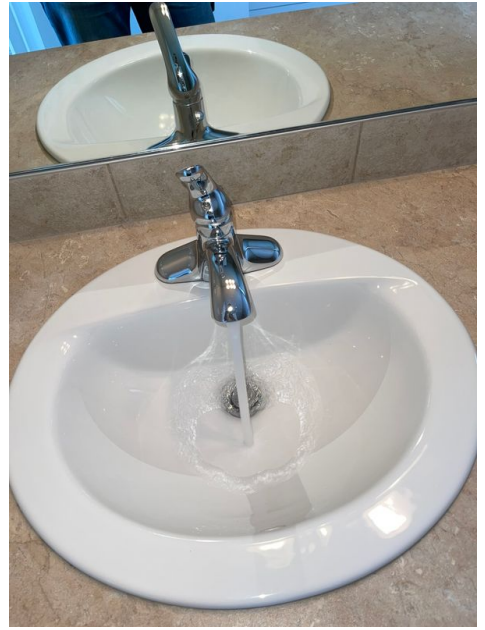
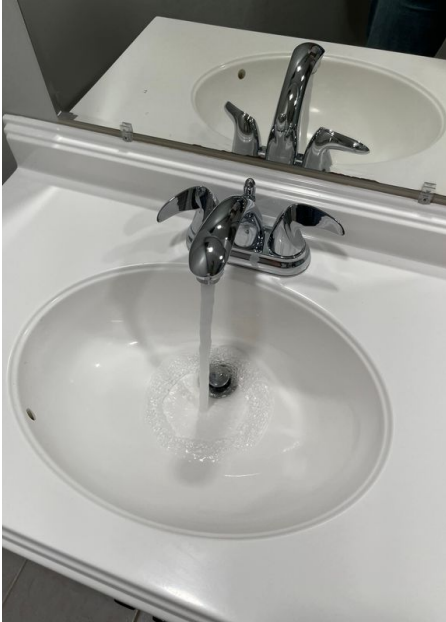
Sinks, Tubs & Showers: Ran Water at Sinks, Tubs & Showers

I ran water at all bathroom sinks, bathtubs, and showers. I inspected for deficiencies in the water supply by viewing the functional flow in two fixtures operated simultaneously.

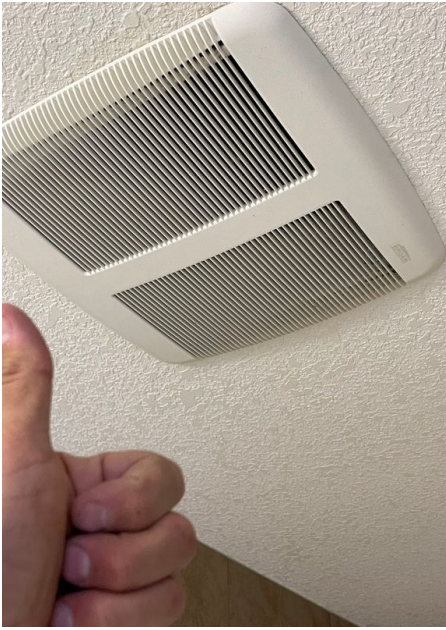
Bathroom Exhaust Fan / Window: Inspected Bath Exhaust Fans

I inspected the exhaust fans of the bathroom(s). All mechanical exhaust fans should terminate outside. Confirming that the fan exhausts outside is beyond the scope of a home inspection.

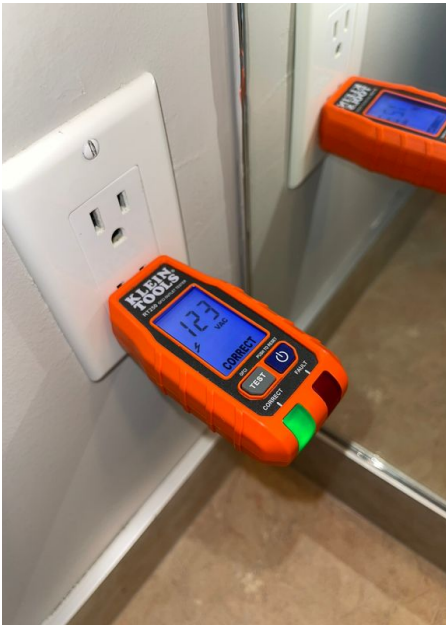
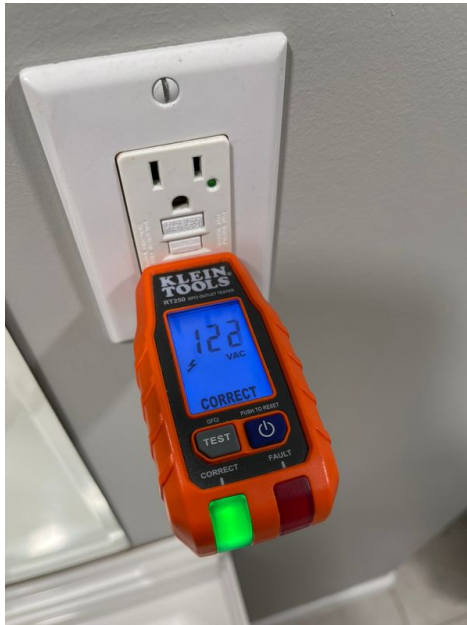
GFCI & Electric in Bathroom: GFCI-Protection Tested

I inspected the GFCI-protection at the receptacle near the bathroom sink by pushing the test button at the GFCI device or using a GFCI testing instrument.

All receptacles in the bathroom must be GFCI protected.

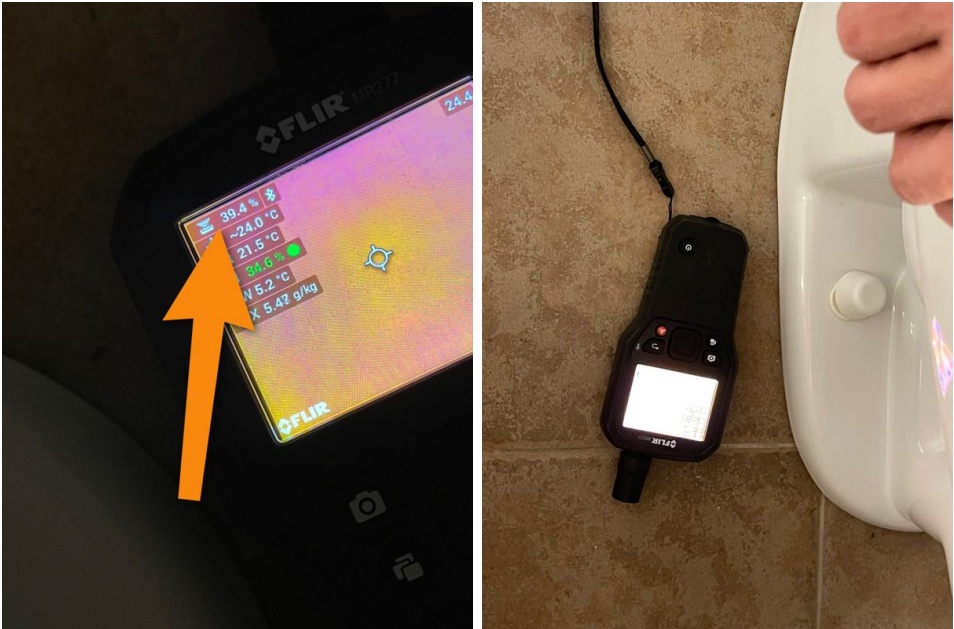
12.2.1 Bathroom Toilets

My moisture meter detected a moisture % of 39.4 - this is high and could indicate water seepage from the wax seal. Further investigation is required. House is vacant and this couldn't of come from a shower or routine use

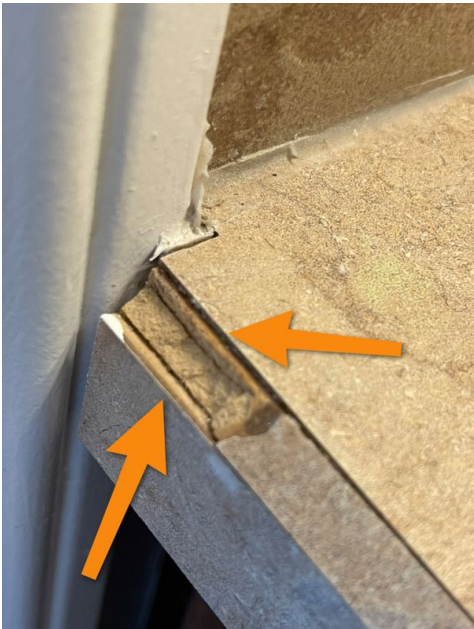
12.7.1 Cabinetry, Ceiling, Walls & Floor
COUNTER TOP DAMAGE

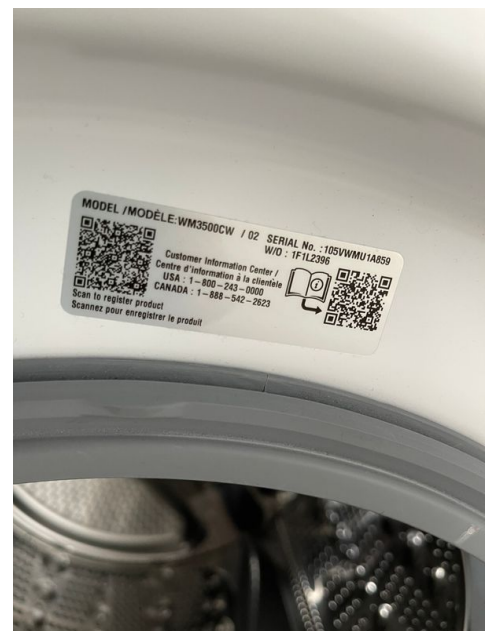
Clothes Washer

DID NOT INSPECT

I did not inspect the clothes washer and dryer fully. These appliances are beyond the scope of a home inspection. I did not operate the appliances. The clothes dryer exhaust pipe must be inspected and cleaned every year to help prevent house fires.

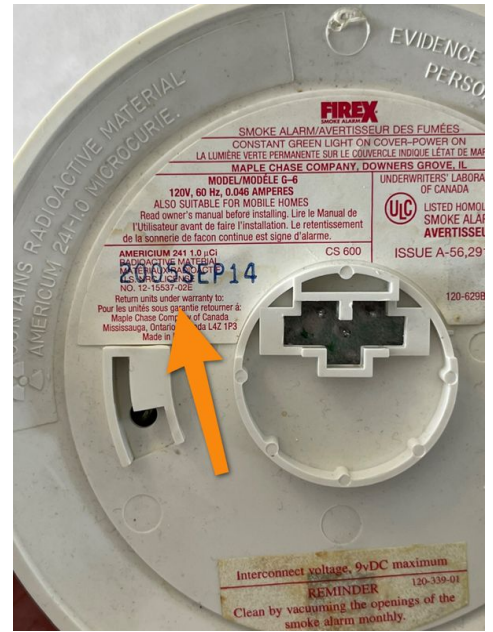
I observed indications of old smoke detectors in the house. Detectors should be replaced every 5-10 years. They should be hard-wired with electricity and have a battery backup feature in case the electricity turns off. New smoke detectors are recommended.

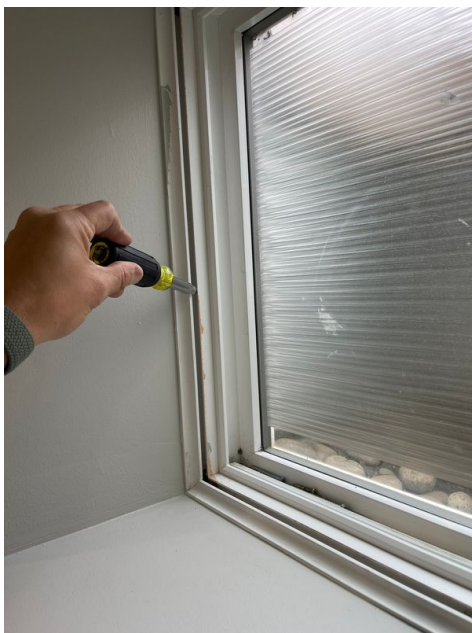
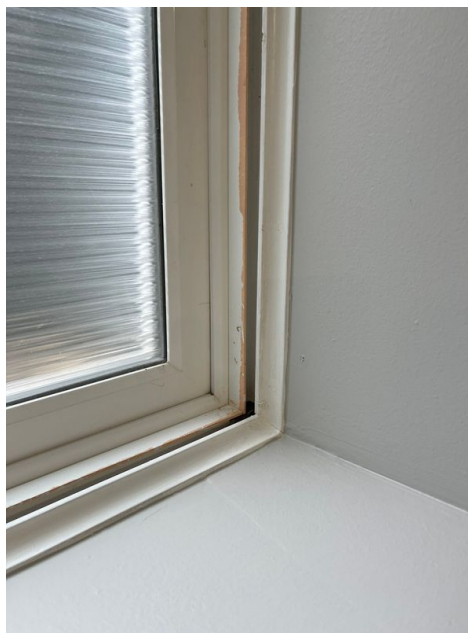
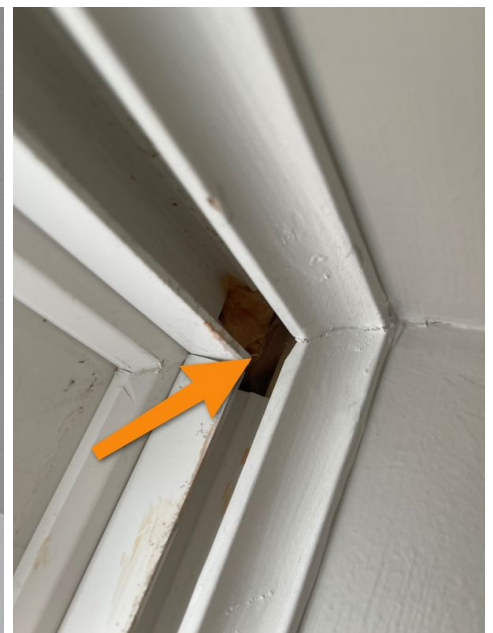
14.3.1 Windows

WINDOWS INSTALL ISSUE

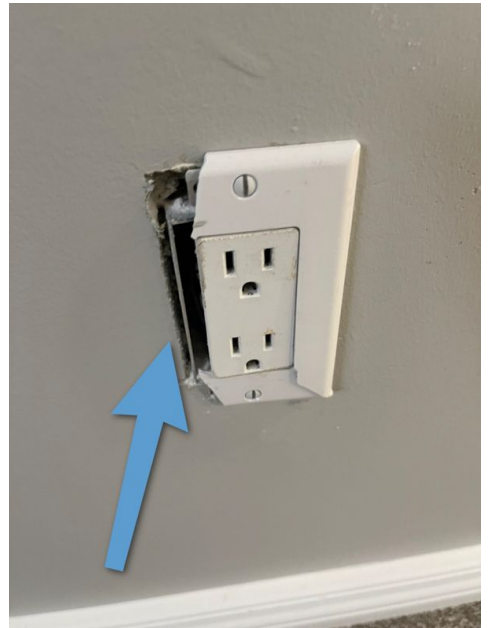
14.4.1 Switches, Fixtures & Receptacles

COVER PLATES MISSING OR DAMAGED

I observed one or more wall receptacles with a missing or damaged cover plate.

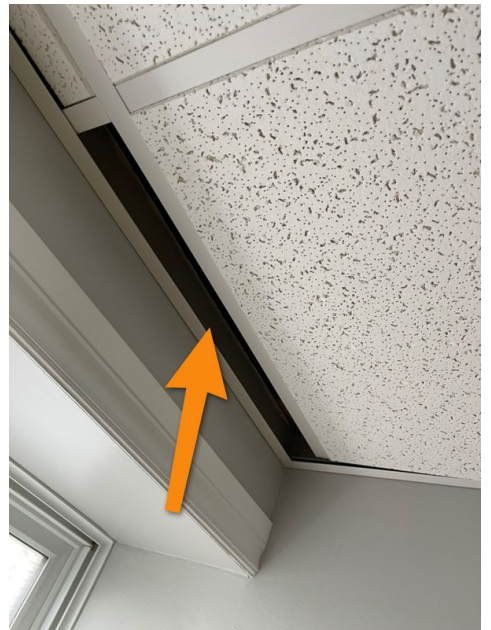
14.5.1 Floors, Walls, Ceilings

MISSING CEILING TILES

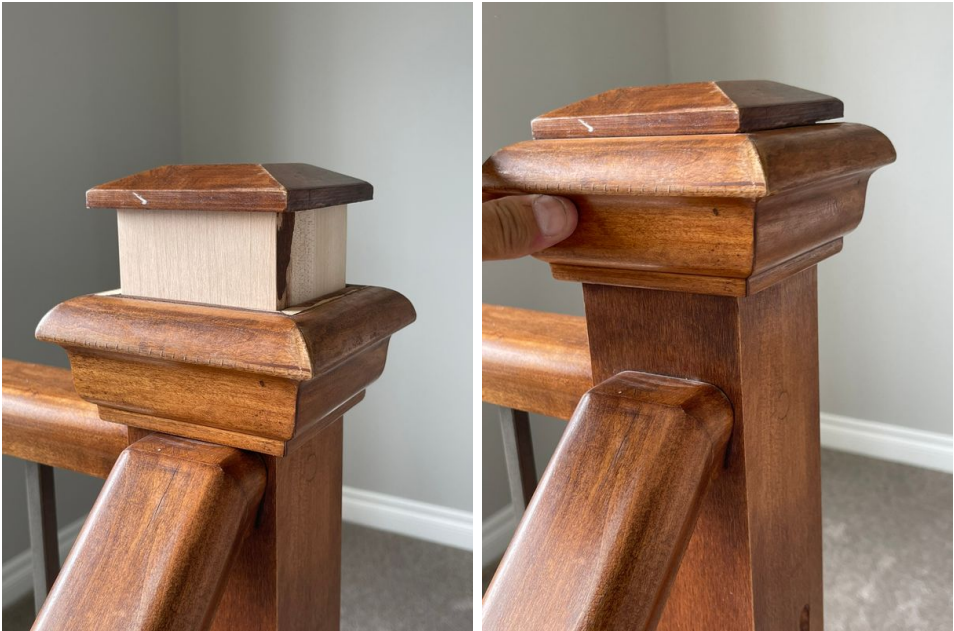
14.6.1 Stairs, Steps, Stoops, Stairways & Ramps

NEWL POST DAMAGE

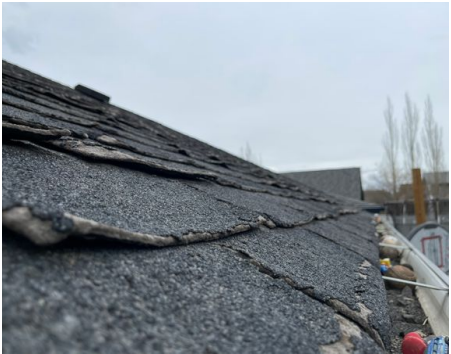
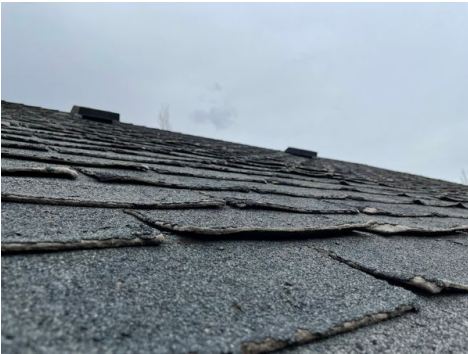
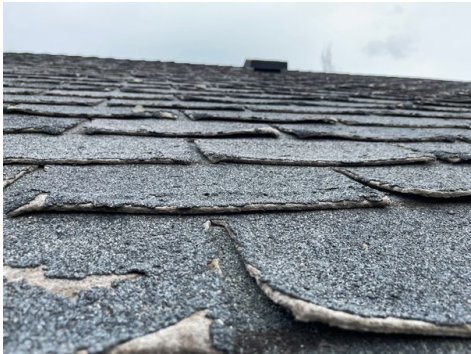
I observed the roof-covering material and attempted to identify its type.
