STANDARD RESIDENTIAL INSPECTION

5426 Thibault Wynd NW
Edmonton, AB T6R 3J1

MAY 13, 2022

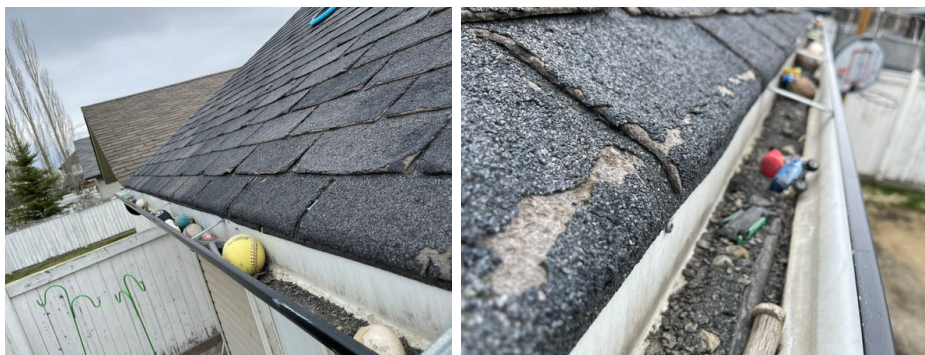
I inspected the gutters. I wasn't able to inspect every inch of every gutter. But I attempted to check the overall general condition of the gutters during the inspection and look for indications of major defects.

Monitoring the gutters during a heavy rain (without lightening) is recommended. In general, the gutters should catch rain water and direct the water towards downspouts that discharge the water away from the house foundation.

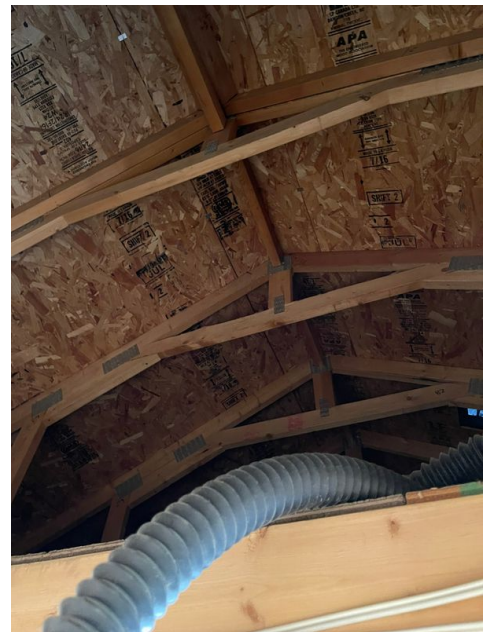
PERSONAL STORGE RESTRICTION

Could not access garage attic area

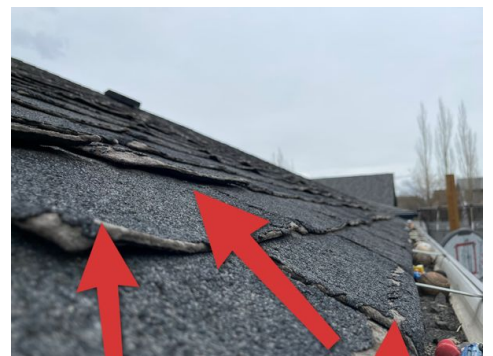
15.2.1 Roof Covering

MATERIAL DEFECT OBSERVED

Material Defect. A material defect was observed. According to the [InterNACHI Home Inspection Standards of Practice](#), a material defect is a specific issue with a system or component of a residential property that may have a significant, adverse impact on the value of the property, or that poses an unreasonable risk to people. The fact that a system or component is near, at, or beyond the end of its normal, useful life is not, in itself, a material defect.

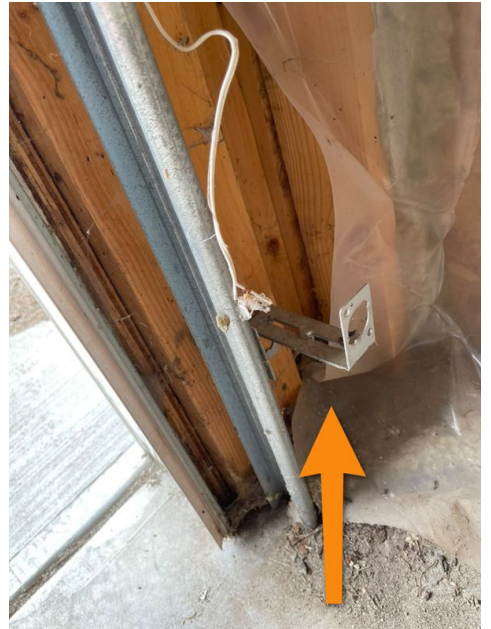
I observed that the photo-electric eyes are installed too high from the garage floor surface or missing

The vertical distance between the photo-eye beam and the floor should be no more than 6 inches.

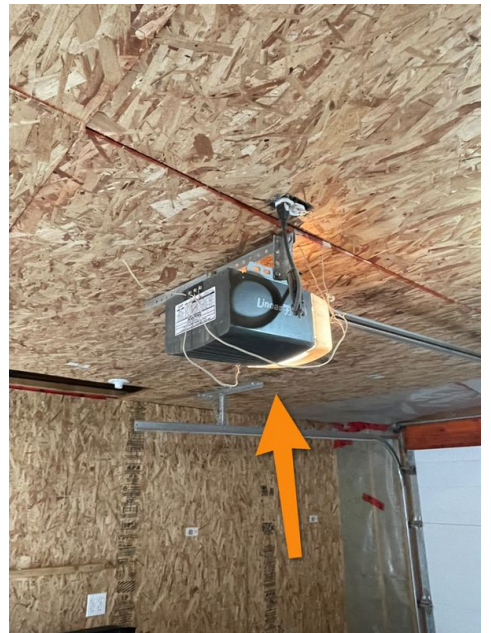
15.12.2 Garage Vehicle Door Opener

WALL BUTTON DID NOT FUNCTION

Major Defect

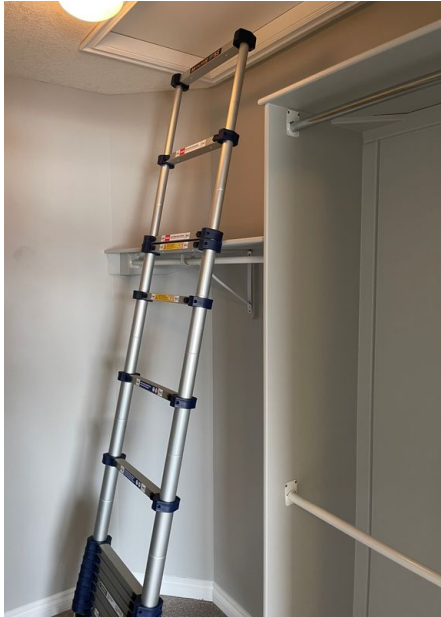
Structural Components & Observations in Attic: Location of Attic Hatch

Master Bedroom, Closet

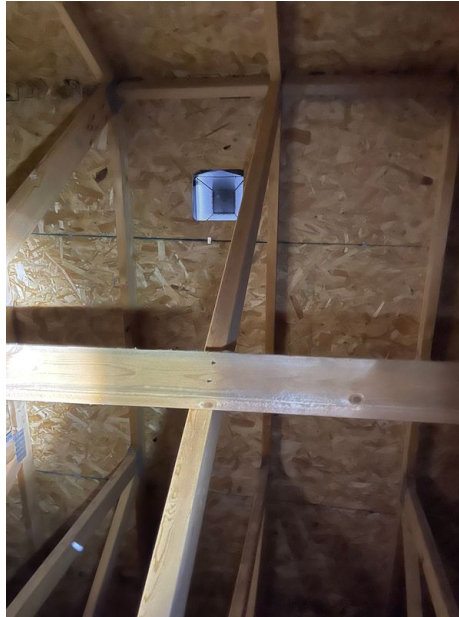
Structural Components & Observations in Attic: Roof Deck Material

OSB

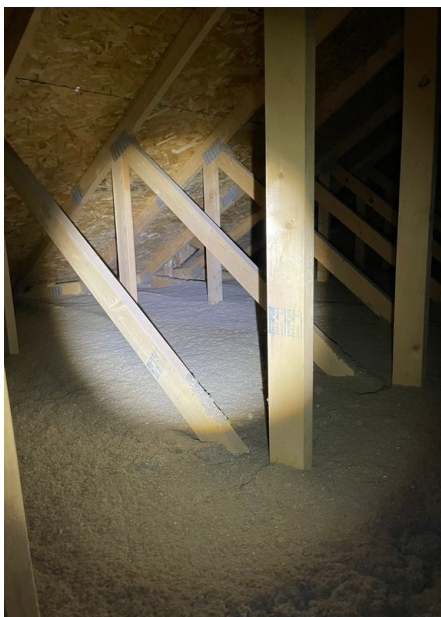
Structural Components & Observations in Attic: Type of Roof Structure

Engineered Truss System

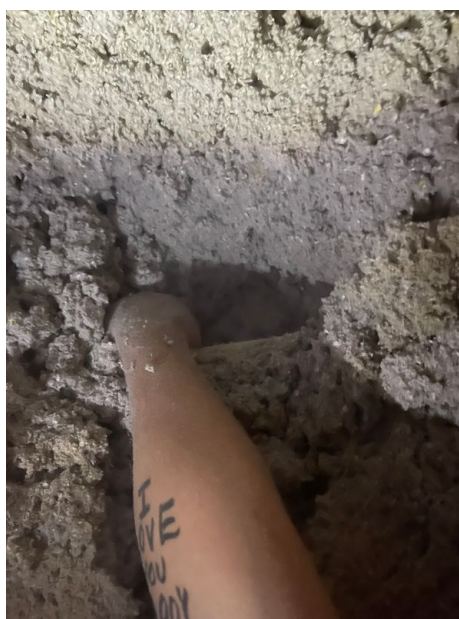
Insulation in Attic: Type of Insulation Observed

Fiberglass, Blown

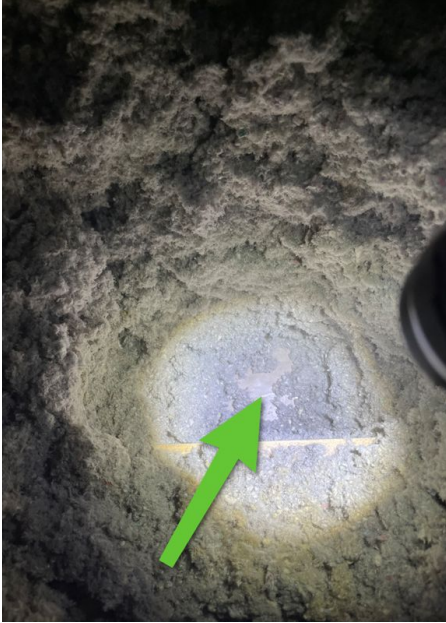
I report as in need of correction the general absence of vapor barrier in unfinished spaces.
